# BioBase survey report

Holkham Lake, August 2019

This report provides a summary of results from a recent acoustic mapping survey. The survey was carried out for the East Anglia Area (FBG) to provide bathymetry, vegetation and bed type mapping. The information will inform an evidence-based approach to managing the fishery.

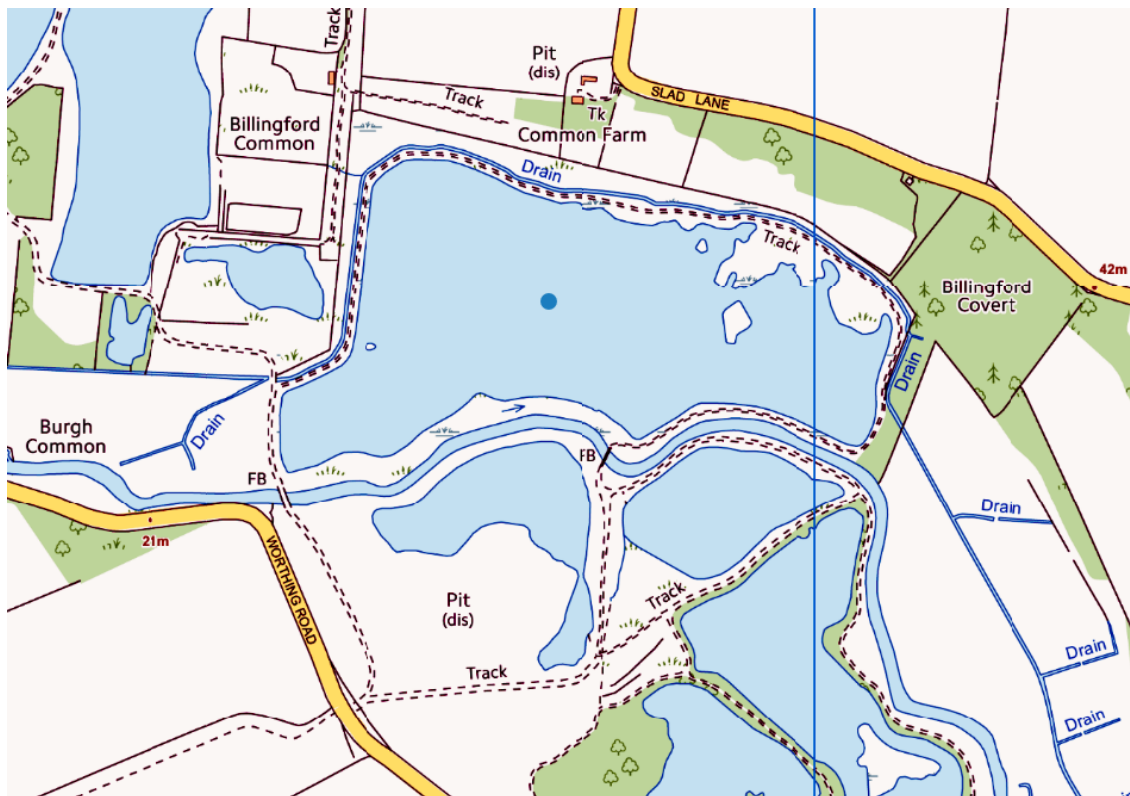
- 10.4 hectares
- NGR: TG 01739 19518
- 29<sup>th</sup> August 2019
- Transducer depth = 0.3m below water surface.

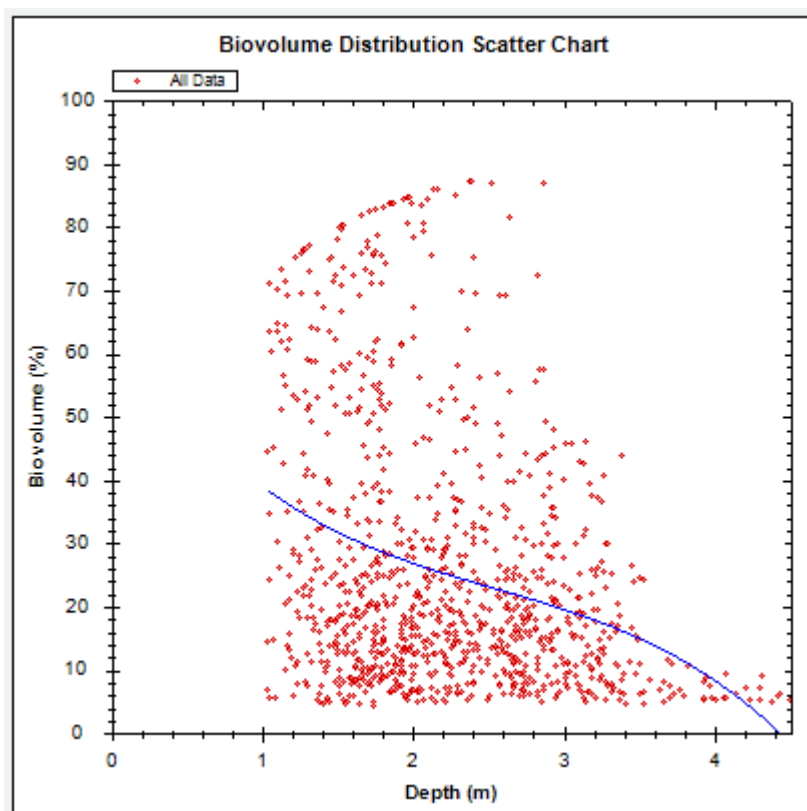
Maximum vegetation colonisation depth (point data).

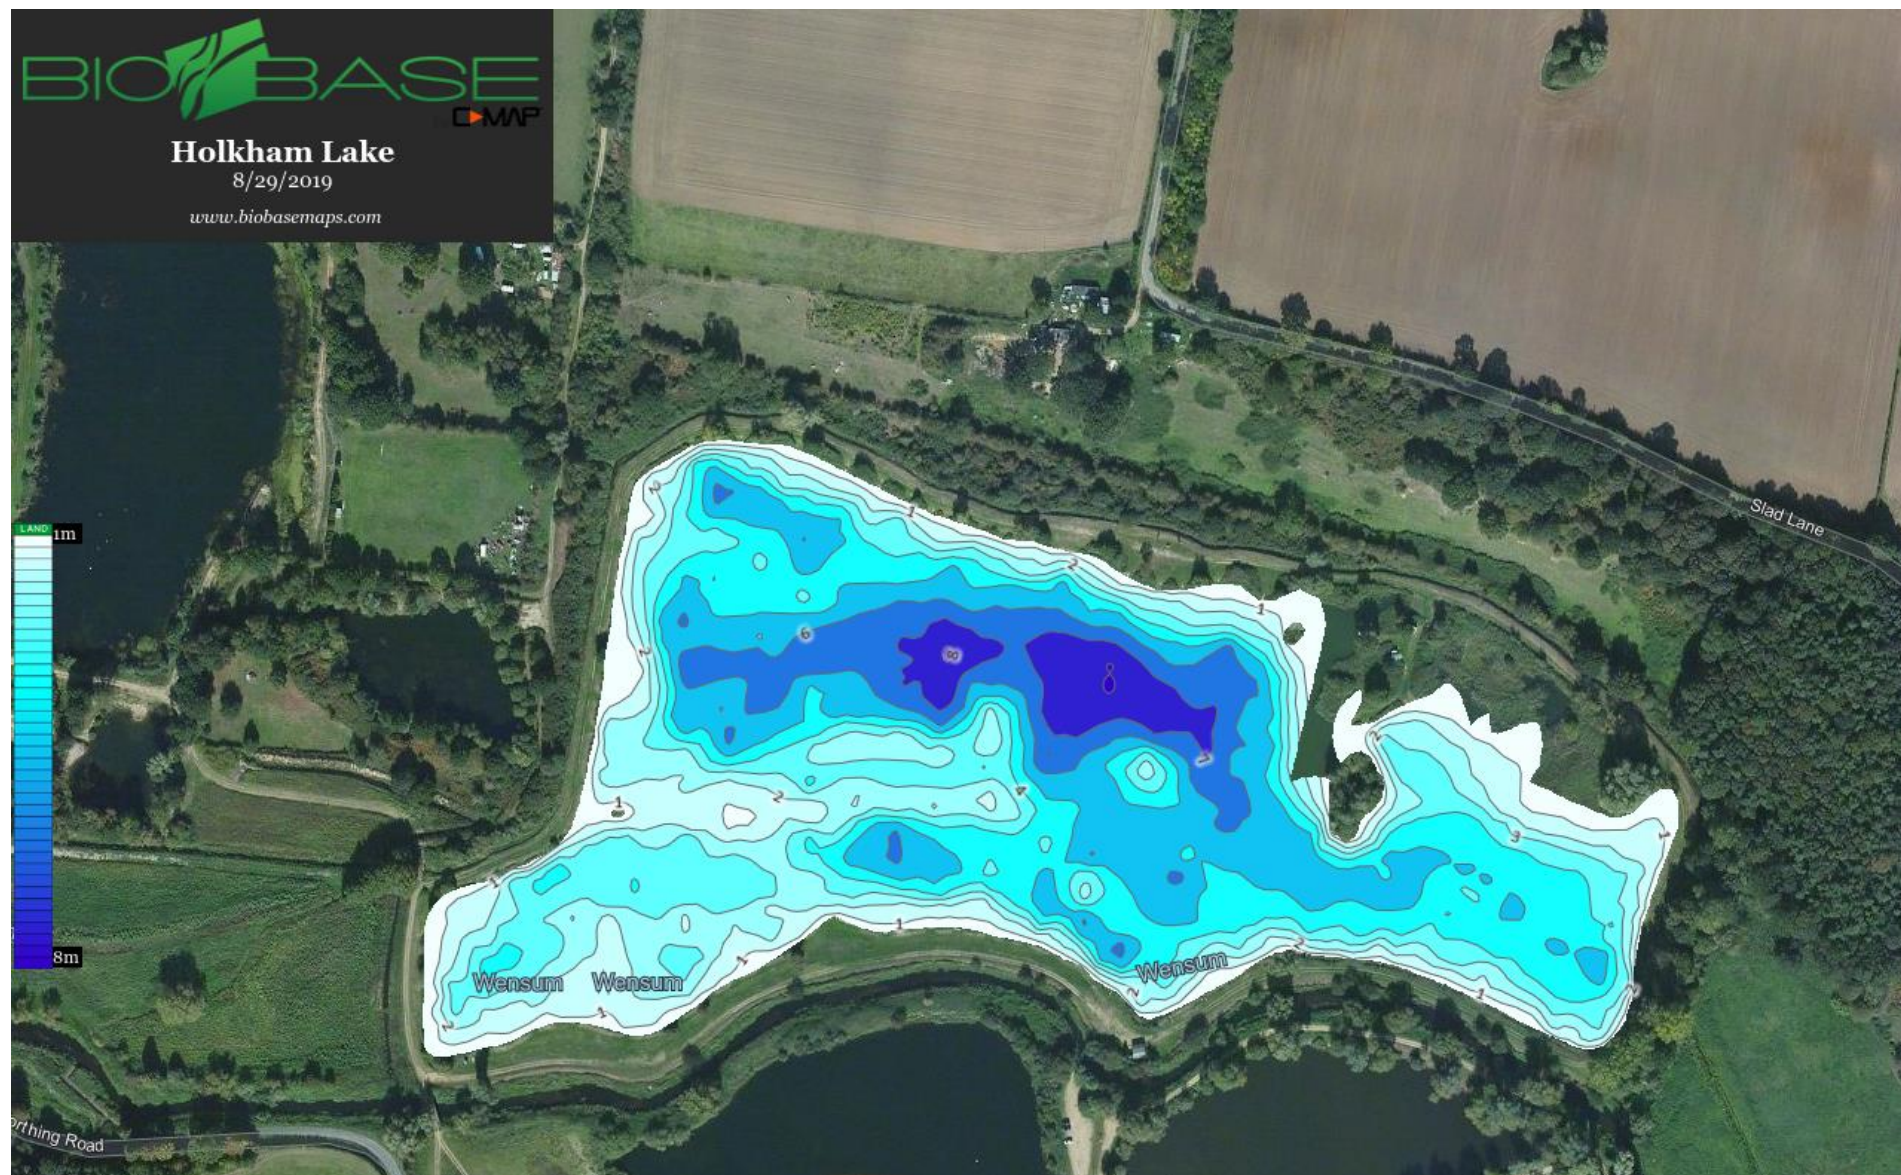
Bathymetry map (depth contour values in metres: 1m – 9m)

Bathymetry data (grid) shows a maximum depth of 8.13 m. Bathymetry data shows depth is greatest in a central area north of the main east-west bar. A number of channels run parallel to the main east-west bar. No significant area of even depth was found although the eastern end of the lake has less pronounced depth variation.

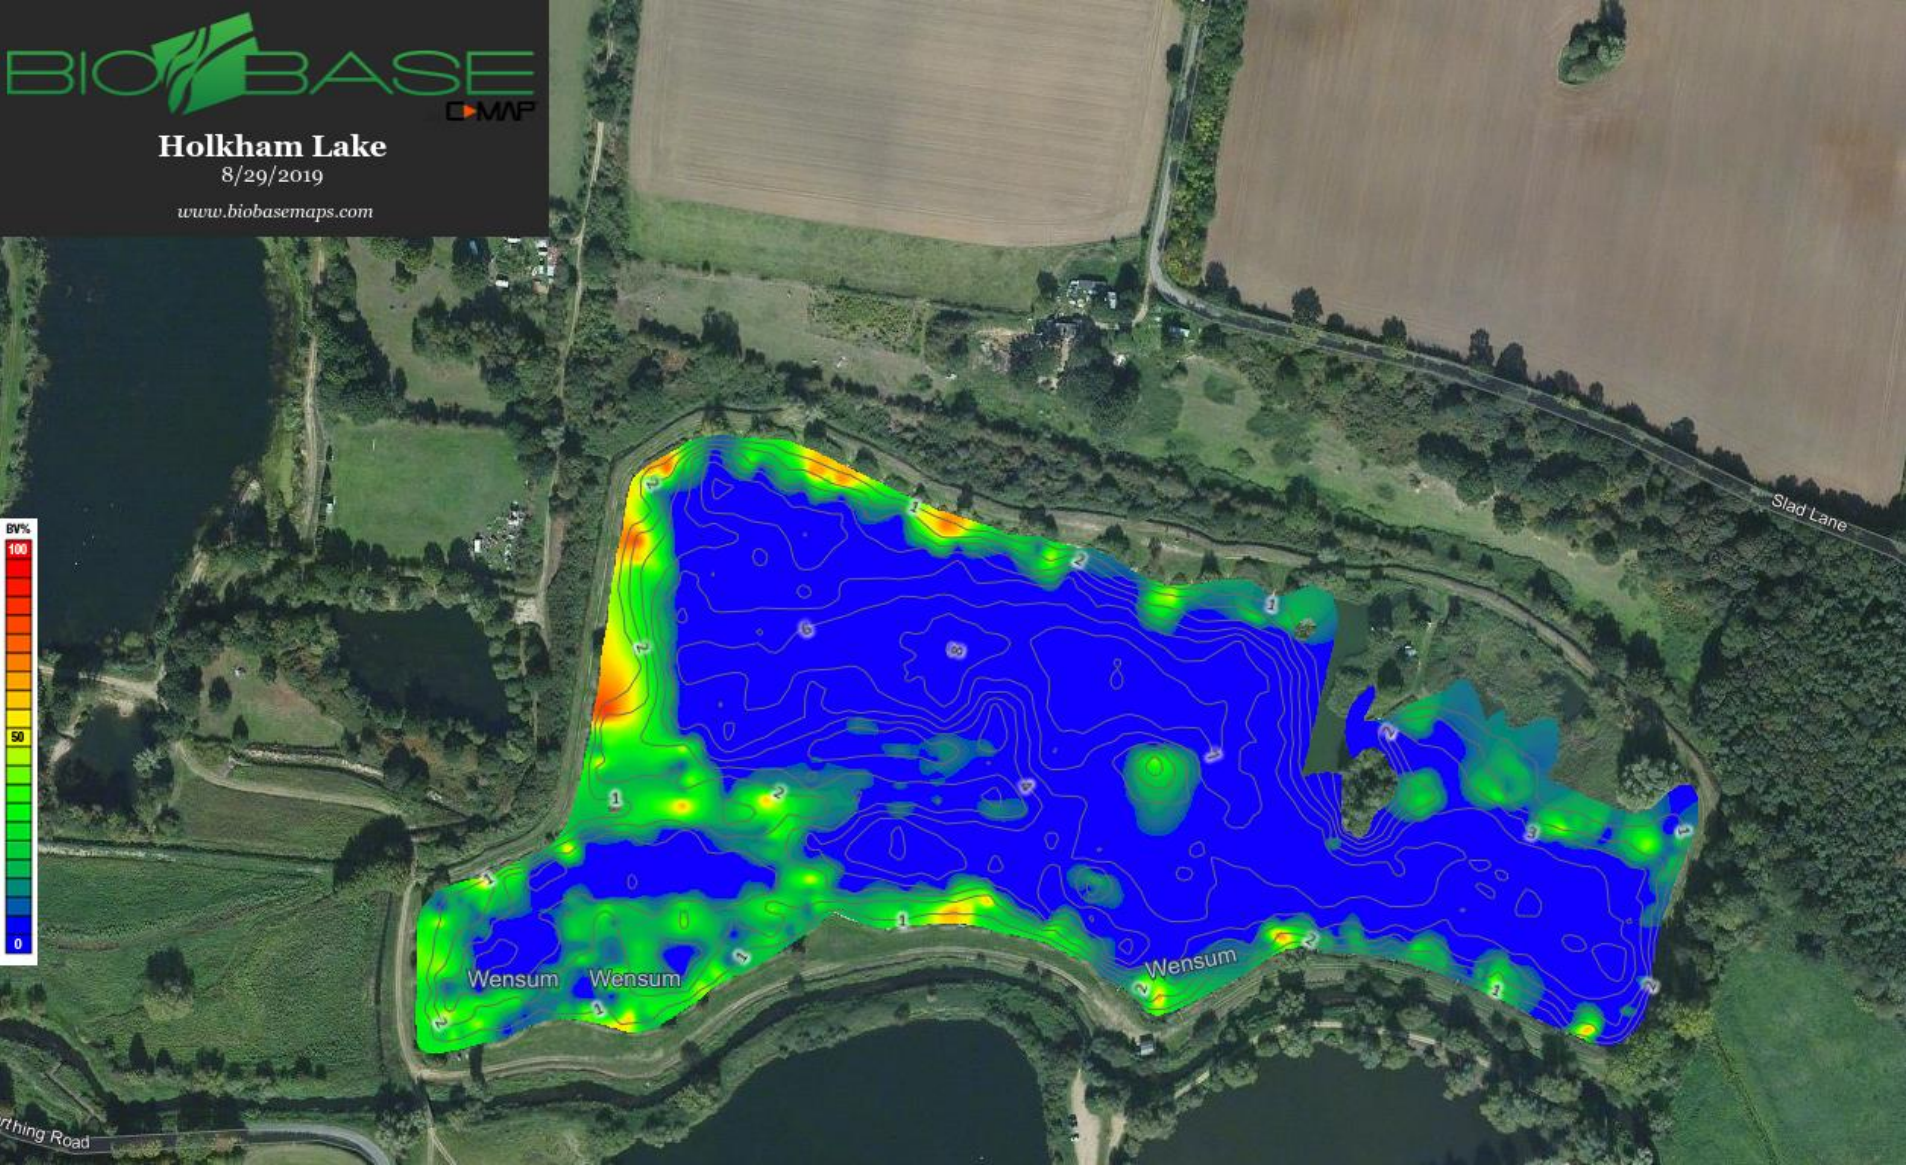
Vegetation map (percent biovolume: 0-100)<sup>1</sup>

Submerged vegetation covers 38% (grid) of the lake bed. Vegetation was recorded to a maximum depth of 4.5 m. Biovolume levels are generally low across extensive areas of the lake. Distinct elevation in vegetation presence is found across the central east-west bar of the lake. Highest biovolume values were located at the western end of this bar. Other locations with substantial vegetation cover were towards the eastern end of the main bar and in the north-east corner of the lake.

<sup>1</sup> Percent biovolume (otherwise known as Percent Volume Inhabited or PVI) represents the percent of the water column occupied by plant matter at each GPS location. It's a simply plant height divided by water depth multiplied by 100 for the collection of pings bound to each GPS location along a traveled path. Biovolume ranges from 0% (bare bottom) to 100% (vegetation growth to the surface).

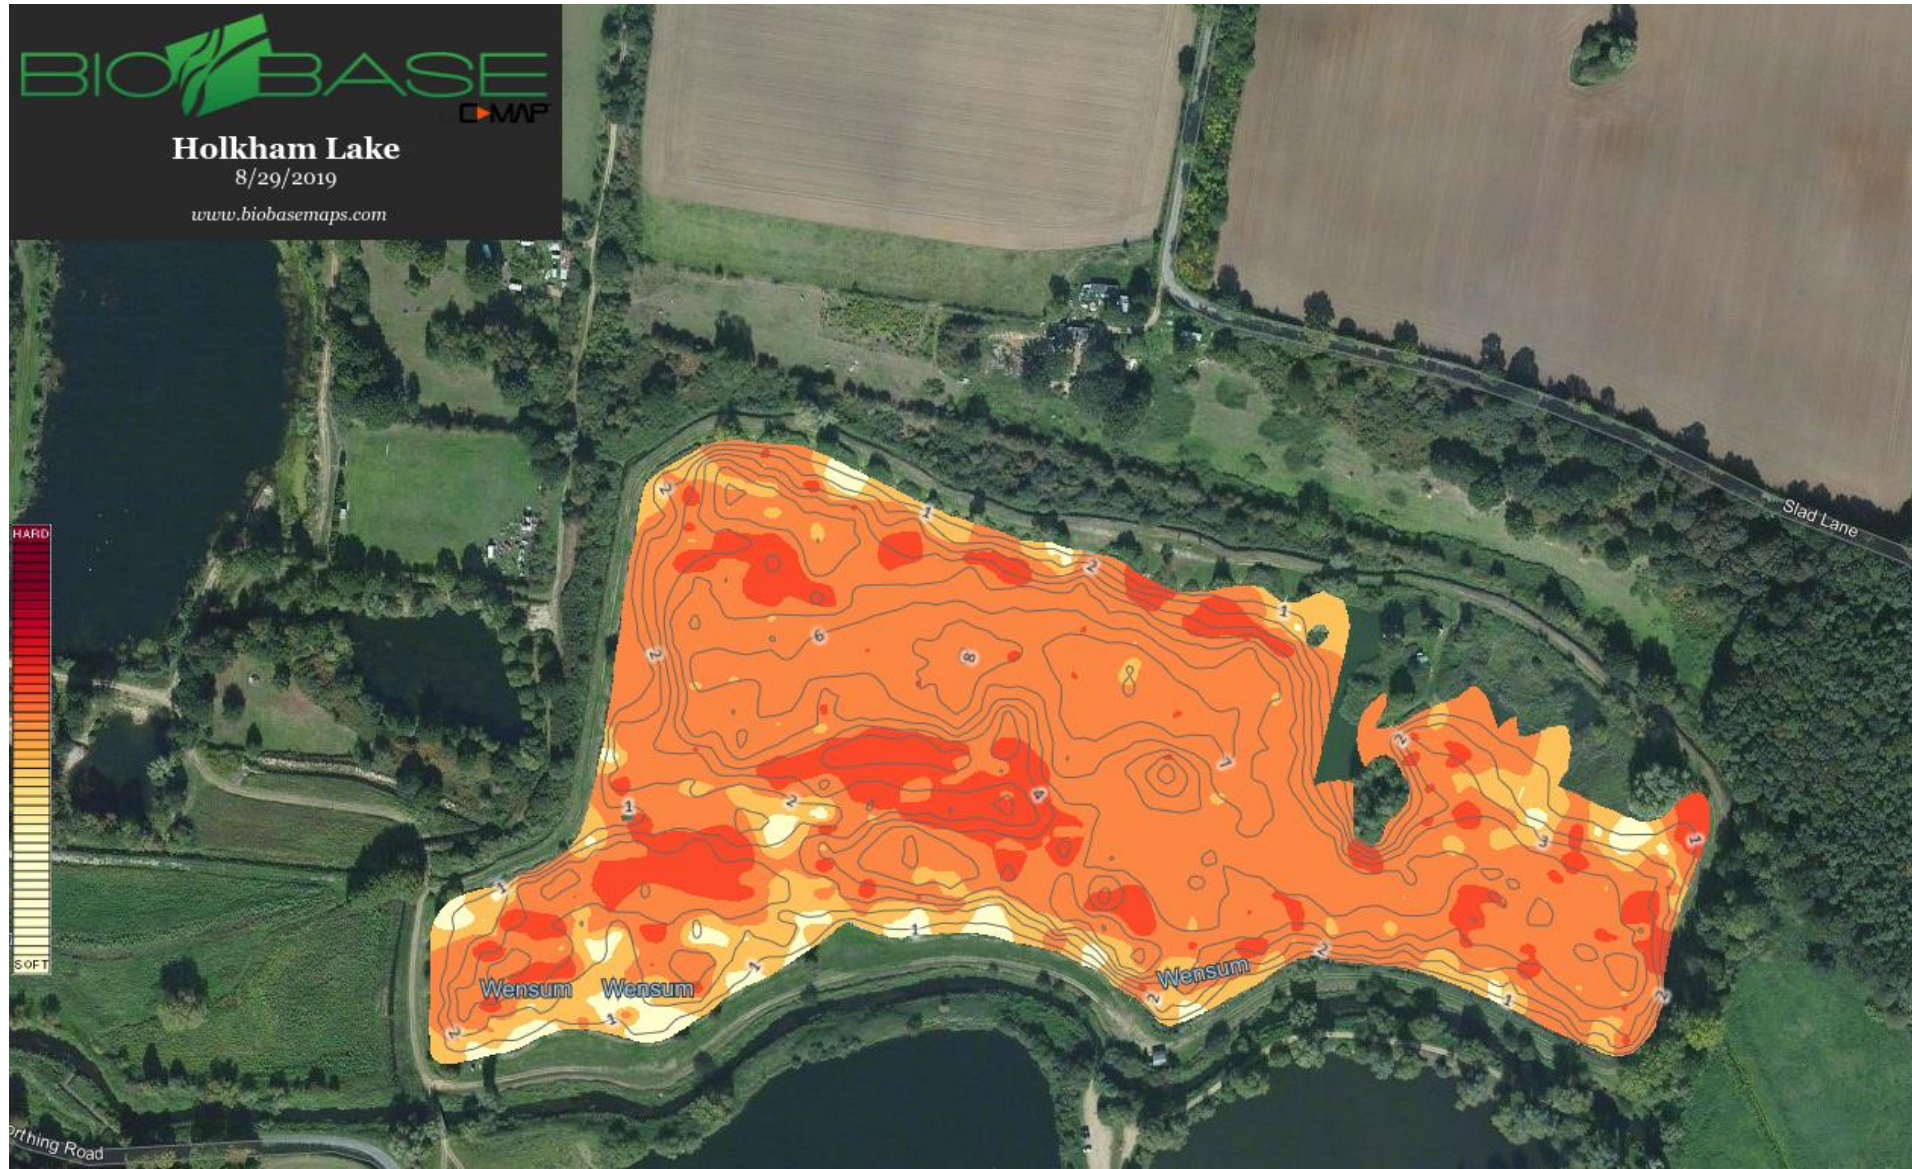
Bed type map (relative hardness:  $0-0.5)^2$

Bed composition data indicates most (93%) of the substrate to be of medium hardness. The greatest extent of soft substrate is associated with the deepest part of the lake, likely reflecting maximal deposition in this location. Much of the hardest bed was associated with sections towards the western end of the main bar and also throughout the south-west part of the lake. The remaining areas of the lake tended to have a mosaic of bed hardness types.

<sup>2</sup> Bed hardness is a measure of acoustic 'reflectivity'. The hardness data generated is on a relative but continuous scale that ranges from 0-0.25 (soft), 0.25-0.4 (medium) and 0.4-0.5 (hard). Soft bottoms include loose silt or sand. Hard bottoms are compacted sand, gravel and rock.
